O&M Inspection Report
For Navigation and Shore Protection Projects
Honolulu Engineer District
CEPOH-EC-T

1. Project Name: Kahului DDH
2. Date of Inspection: September 16-17, 2002
3. Inspection Personnel:

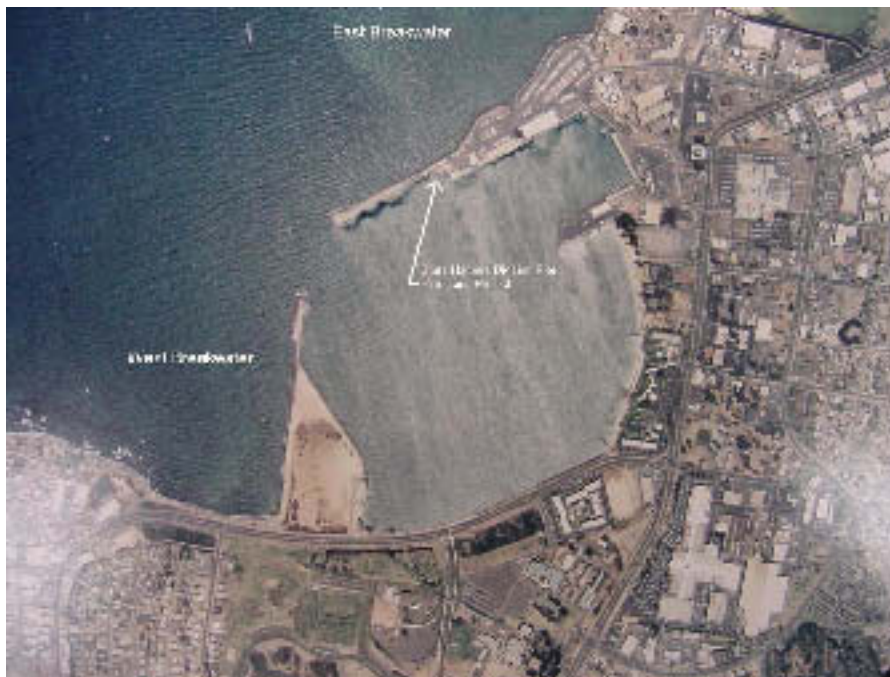
State DOT is continuing their contract work on the Kahului Pier 1 extension (approx. 300'), which they anticipate completing in Dec 02. Pat Tom has contacted Marshall Ando of State DOT to discuss: 1) the resetting of temporarily relocated tribars (relocated for Pier 1 Extension work) back into the breakwater between existing tribars and the Pier 1 Extension; and 2) the removal of miscellaneous Pier 1 Extension materials from our East B/W and revetment structures when their construction work is completed. See photo below:

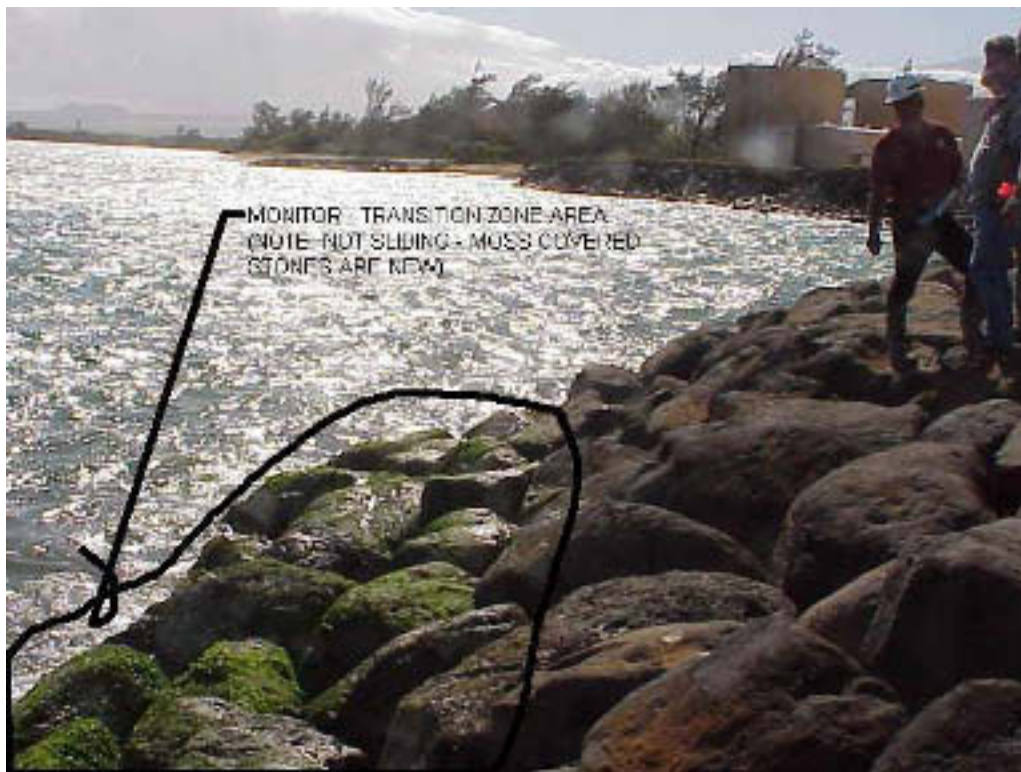
a. Dan's Sta. 3+20 = Revetment Sta. 15+60
Monitor transition zone area. Note - moss covered stone area is not sliding; it was constructed like this. Armor stones placed near the water line by the contractor were covered by moss within a week.

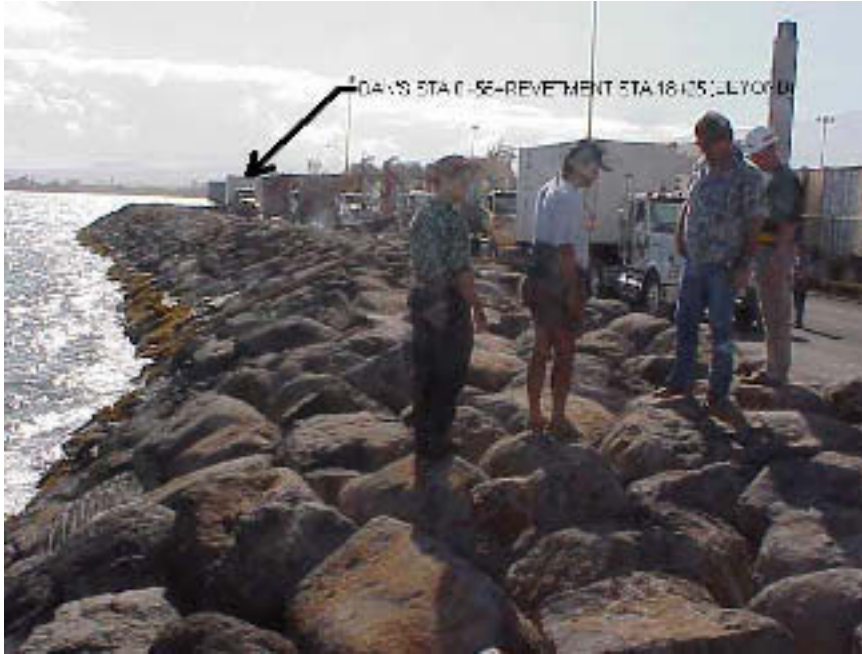
Overview from Dan's Sta. 10+00 to 0+55 = Revetment Sta. 8+80 to 18+25.

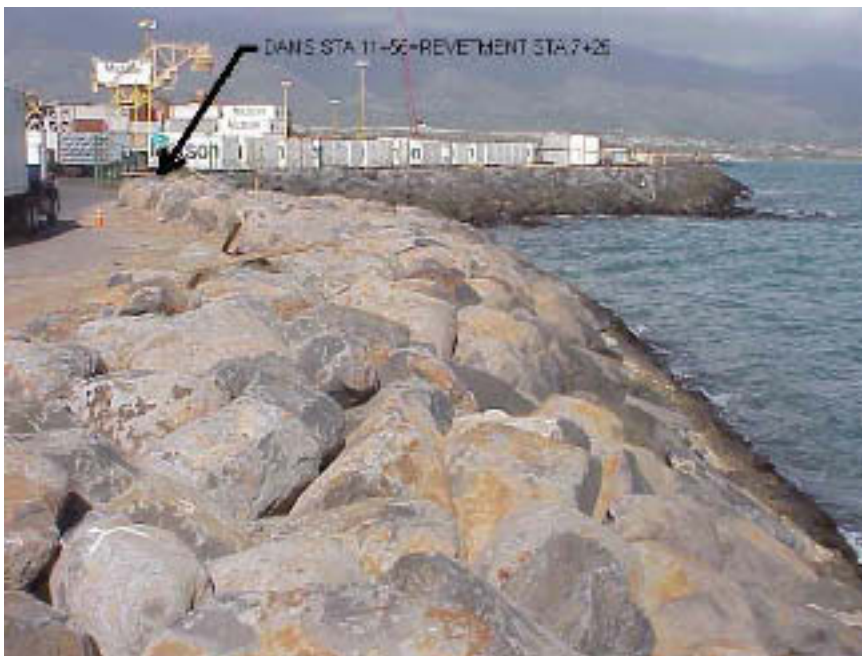
Overview from Dan's Sta. 10+00 to 11+55 = Revetment Sta. 8+80 to 7+25.

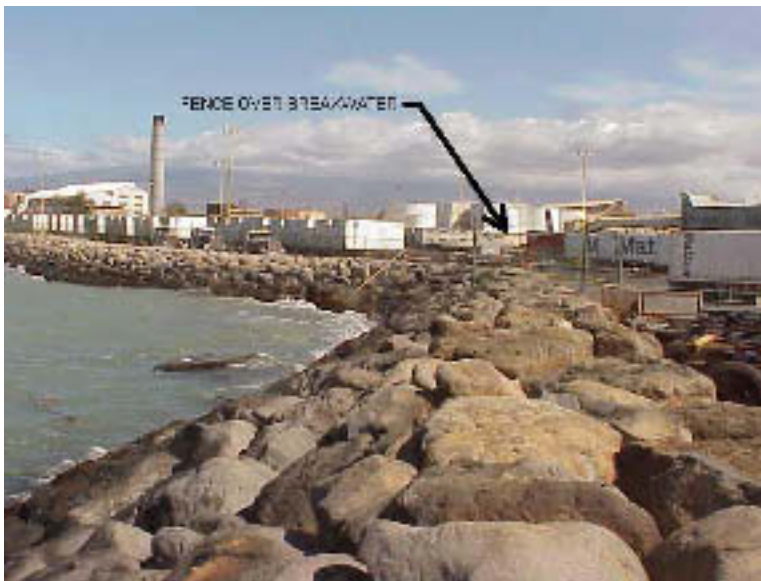
Overview from Dan's Sta. 13+05 to 11+55 = Revetment Sta. 5+75 to 7+25.
(Note: Fence @ Dan's Sta. 12+48 = Revetment Sta. 6+32).

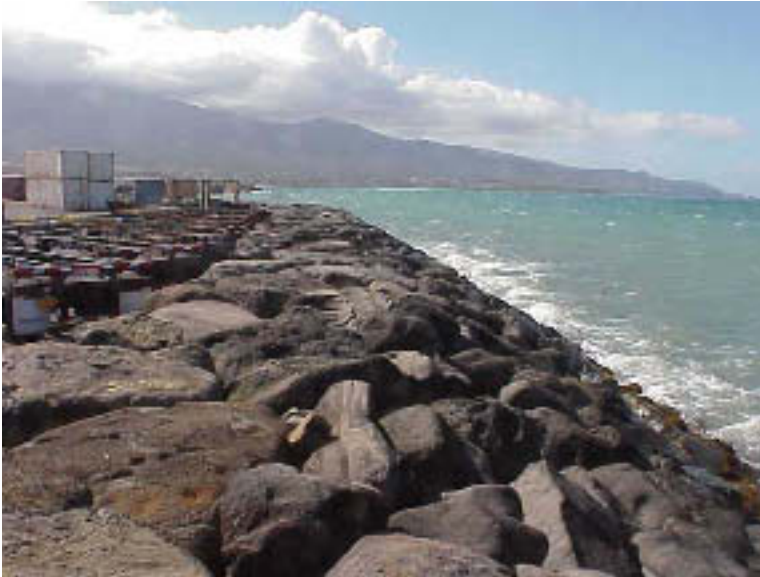
Overview from Dan's Sta. 13+05 to 18+80 = Revetment Sta. 5+75 to 0+00.

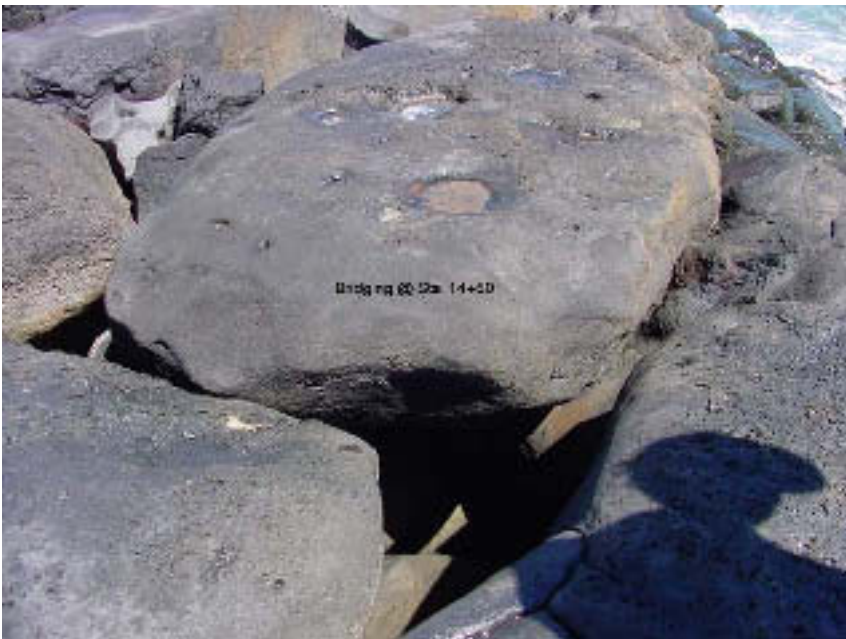
e. *Dan's Sta. 14+00 = Revetment Sta. 4+80
1 armor stone dislodged @ toe, monitor

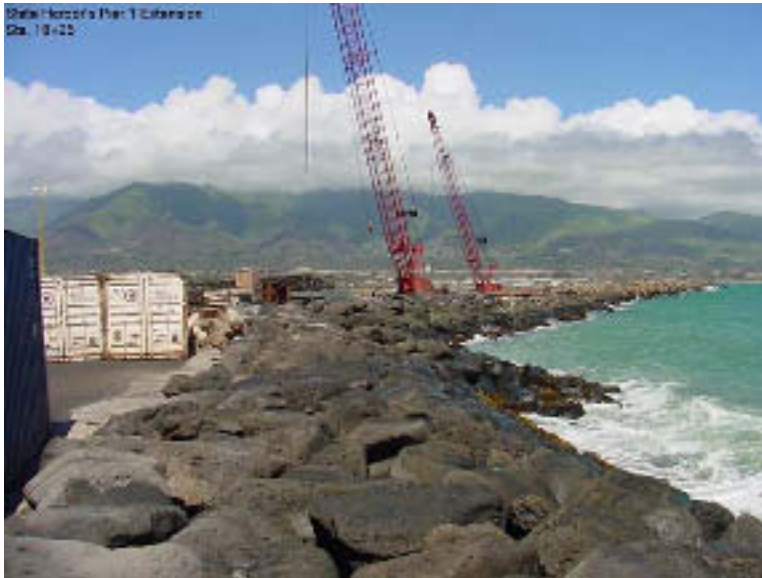
*Dan's Sta. 18+25 = Revetment Sta. 0+55, OS, No change in Armor Stone @ toe.

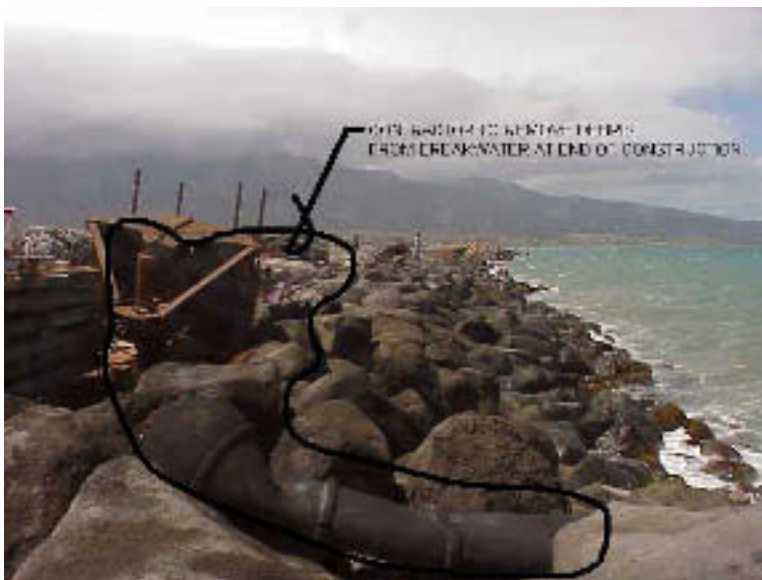
i. Dan's Sta. 18+80 = East B/W Sta. 0+00, Crest, Pier 1 Extension contractor to remove cylindrical rubber sleeve from breakwater at end of his construction work.

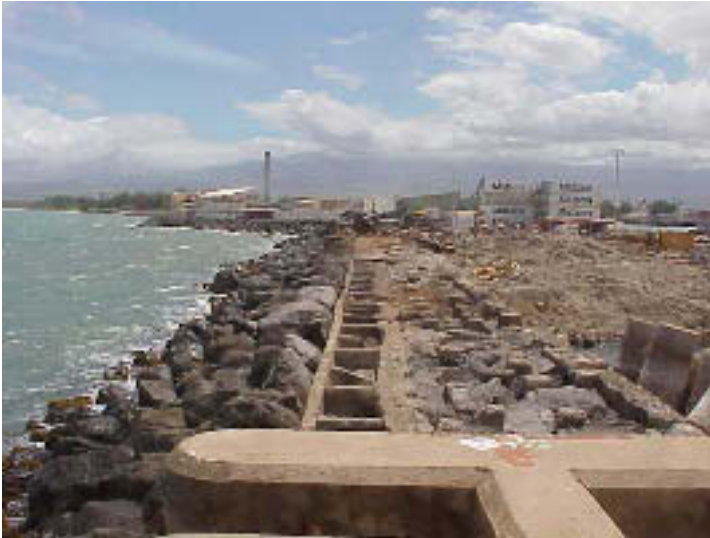
k. Dan's Sta. 19+95 to 24+55 = East B/W Sta. 14+90 to 19+50, Crest, portion of breakwater seems to be lower than the breakwater in previous stations; possible settling of breakwater. Also breakwater seems a bit steeper from Dan's Sta. 24+30 to 24+55 = East B/W Sta. 19+50 to 19+75. Continue to monitor.

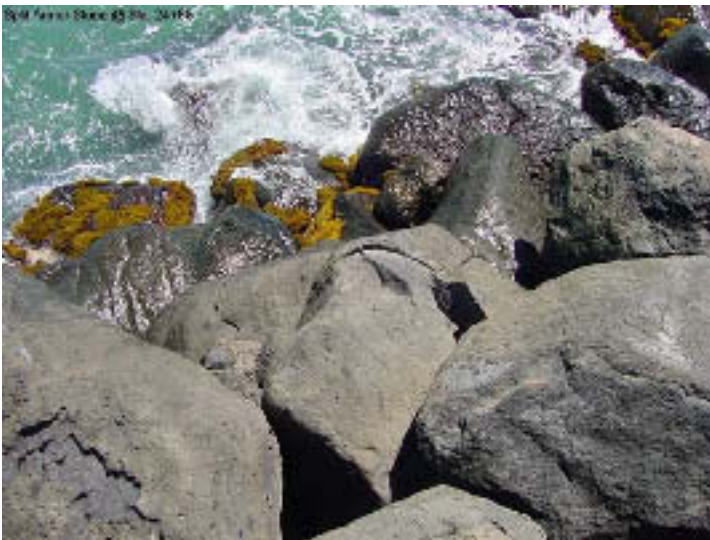
1. *Dan's Sta. 24+55, OS, split armor stones.

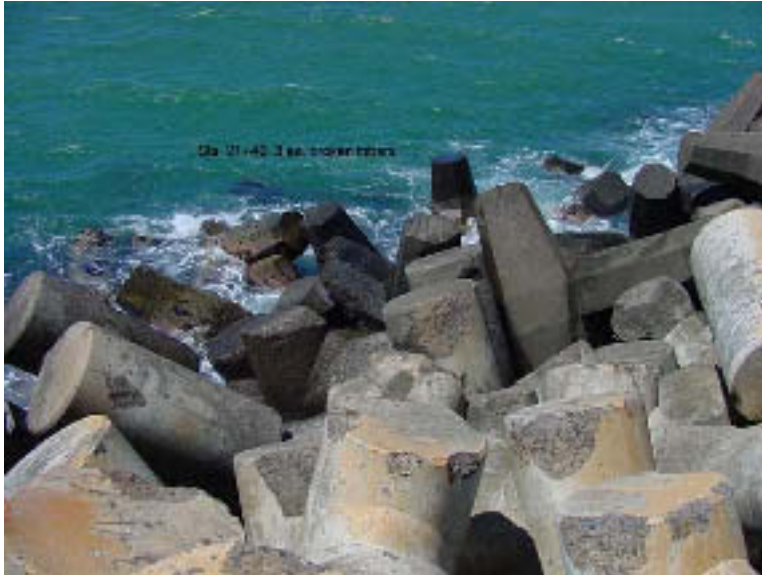
m. *Dan's Sta. 21+45 = East B/W Sta. ???, OS, 3ea. broken dolos.

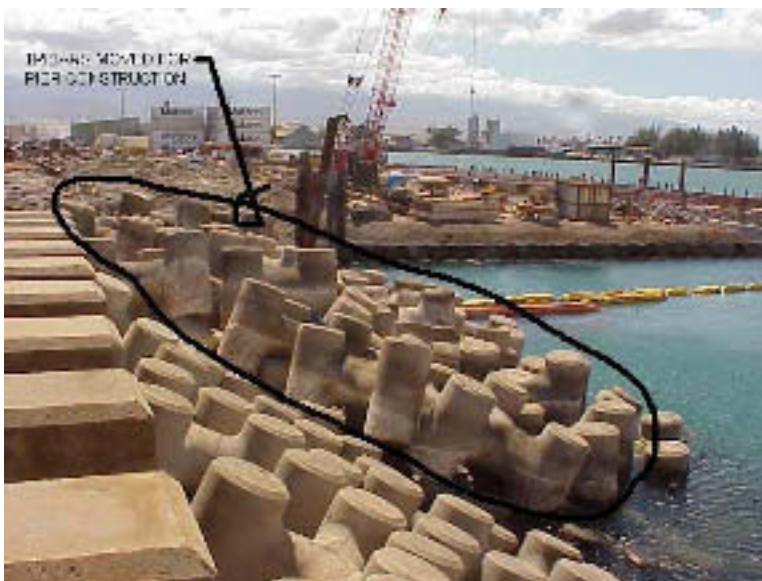
n. Dan's Sta. 24+55 = East B/W Sta. 19+50, HS, tribars moved for pier construction. Contractor will move some of the tribars back to fill void between pier and existing tribars.

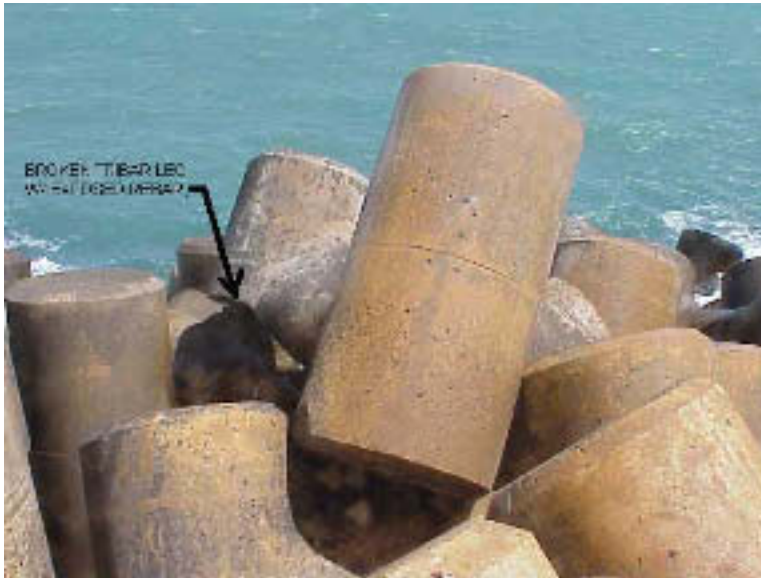
- t. Dan's Sta. 24+85 = East B/W Sta. 19+80, OS, broken tribar leg with rebar exposed.

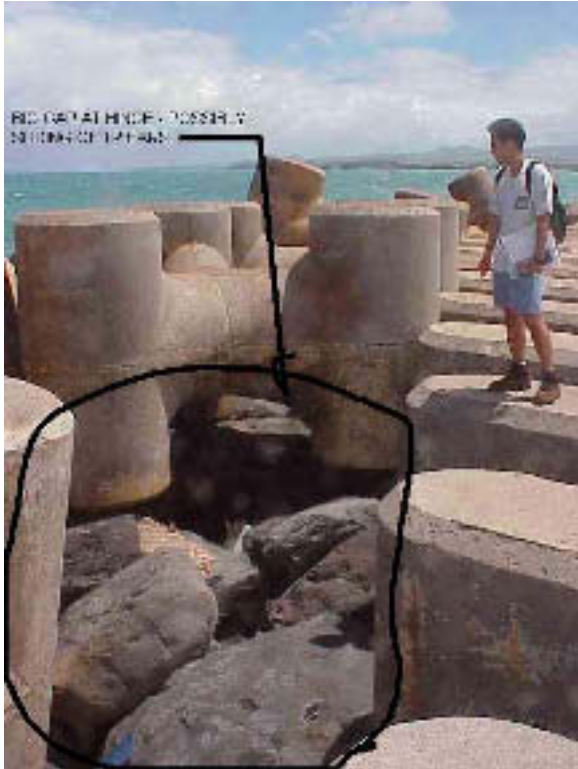
u. Dan's Sta. 24+85 = East B/W Sta. 19+80, OS, big gap at hinge; side slope may be sliding.

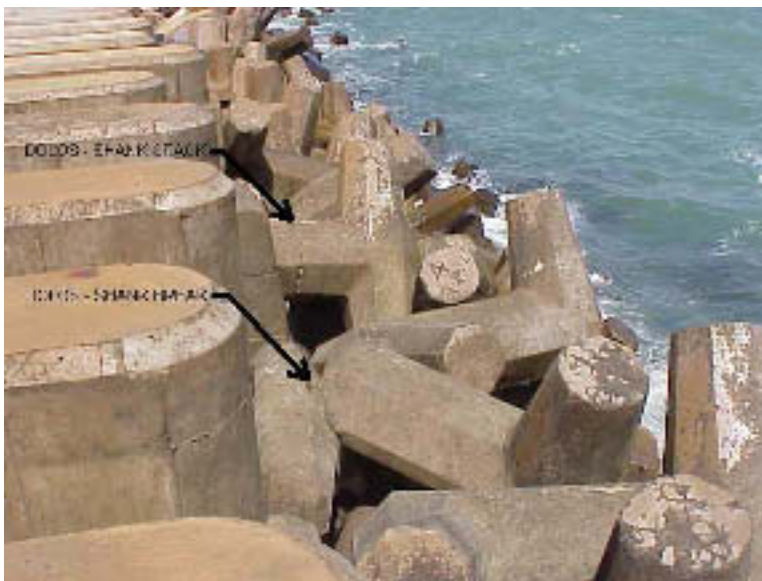
w. Dan's Sta. 25+27 = East B/W Sta. 20+22, OS, 3 Dolos all on side slope: 2 - broken shanks and 1 - cracked shank.

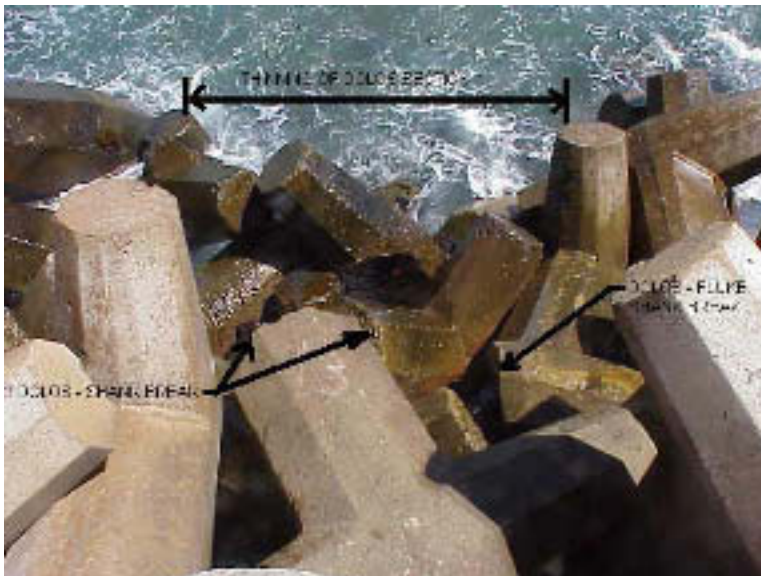
ii. Dan's Sta. 25+93 to 26+11 = East B/W Sta. 20+88 to 21+06, OS, thinning of dolos section. 3 Dolos: 2 - broken shanks and 1 - fluke shank break.

BOTH BREAKWATERS ARE BEGINNING TO SHOW SIGNS OF DOLO MOVEMENT AND SIDESLOPE SETTling, PARTICULARLY BETWEEN STA. 22+50 - 23+00, OCEANSIDE OF THE WEST B/W AND SEPARATION AT DAN'S STA. 26+00 & STA. 29+00, OCEANSIDE OF THE EAST B/W. THESE AREAS NEED TO BE MONITORED AND COMPARED TO PREVIOUS PHOTOGRAPHS ANNUALLY. THE STRUCTURE REMAINS SERVICEABLE AND NO FAILURE IS ANTICIPATED IN THE NEXT YEAR.

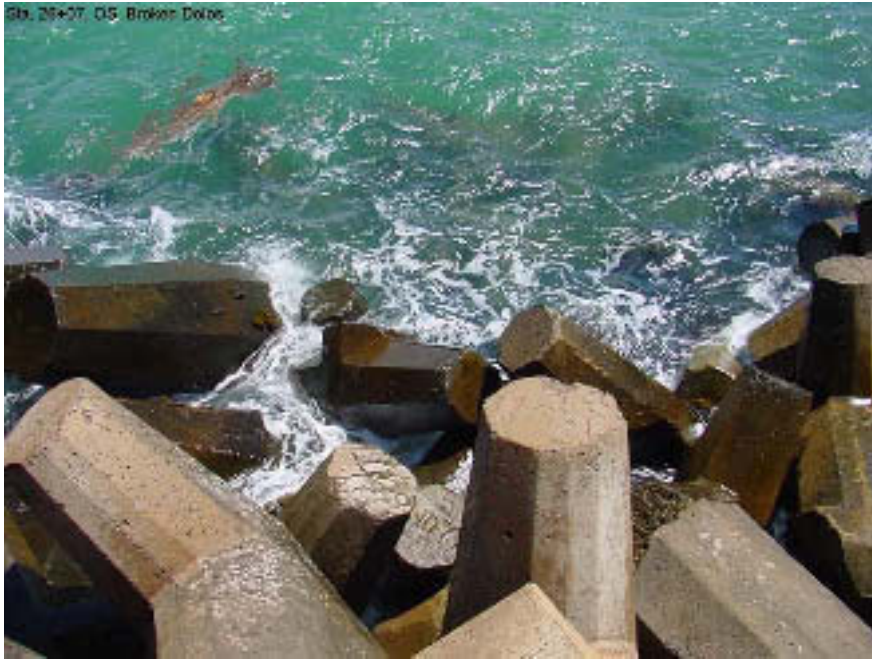
jj. *Dan's Sta. 26+07, OS, dolo separation 6" from RC.

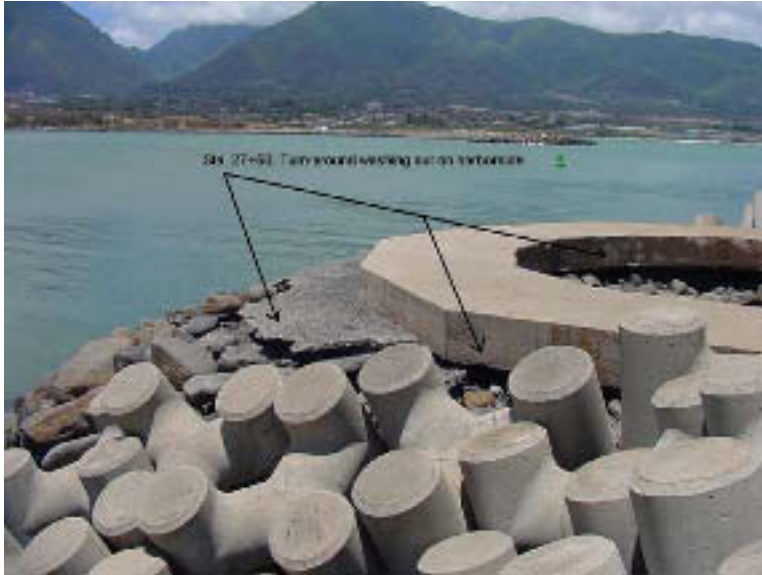
qq. *Dan's Sta. 27+50, HS, material washed-out from under crane turn around.

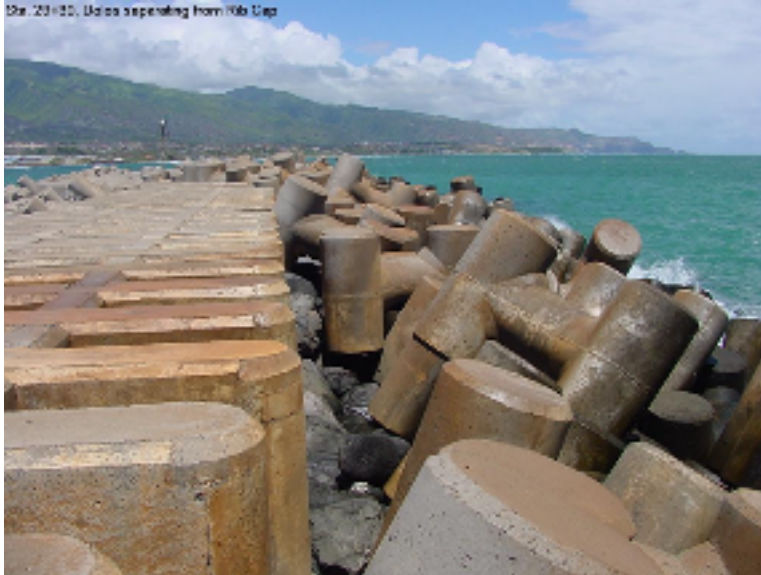
ss. *Dan's Sta. 29+30 - Sta. 30+30, OS, 10' gap between tribars & ribcap 10' x 30' in length.

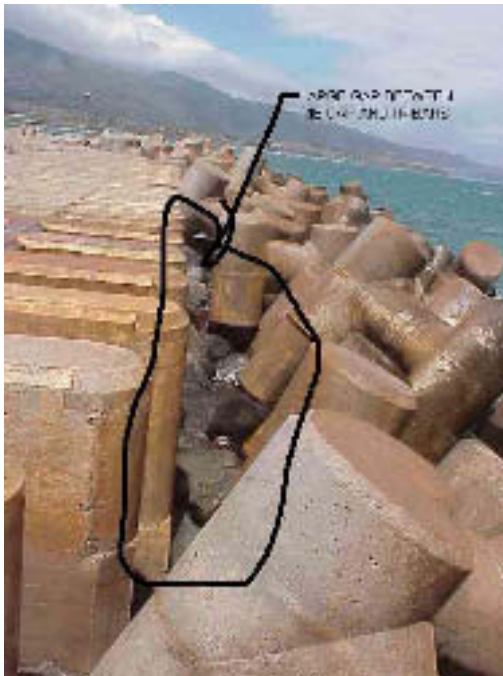
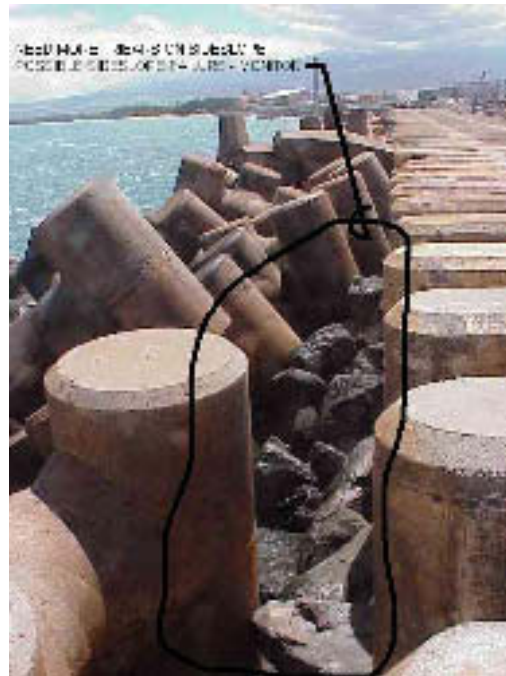
tt. Dan's Sta. 29+18 to 29+42 = East B/W Sta. 24+18 to 24+42, OS, large gap between ribcap and tribars; possible side slope failure. Monitor as required. Left Picture looking towards head. Right Picture looking towards root.

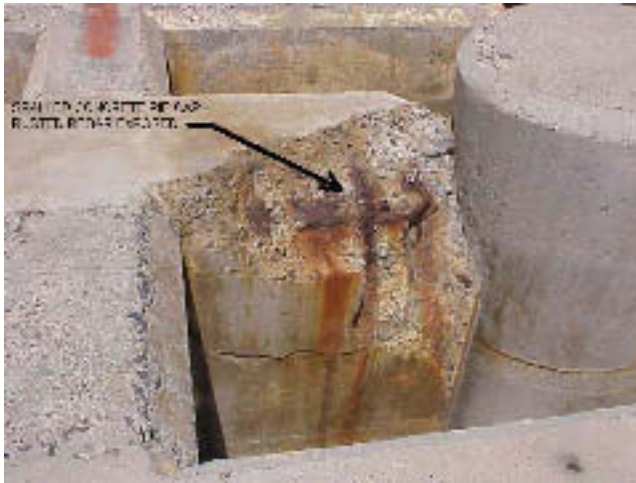
xx. Dan's Sta. 30+37 = East B/W Sta. 25+32, OS, Spalling of ribcap and rusted rebar is exposed (2002 photo).

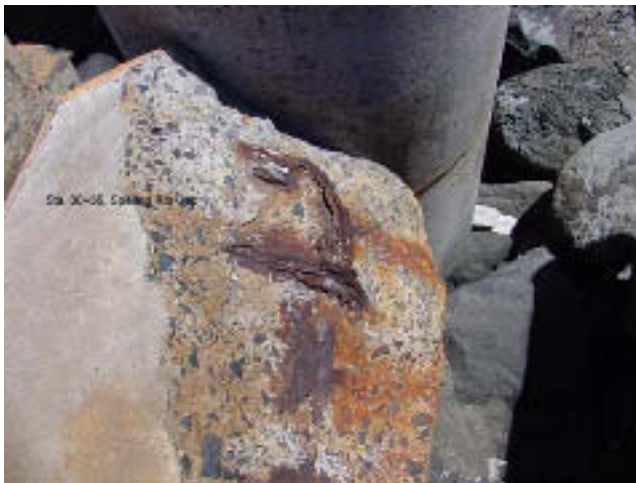
yy. *Dan's Sta. 30+35, OS, rebar exposed in ribcap & spalling. (2001 photo).

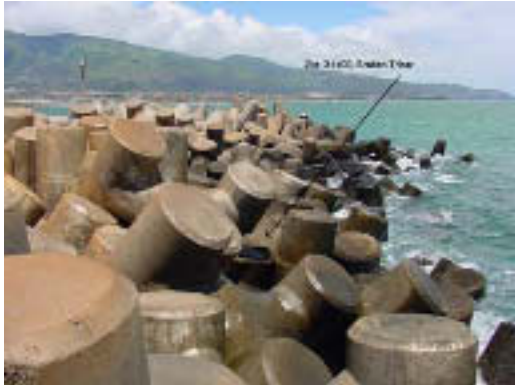
ccc. *Dan's Sta. 31+00, OS, broken tribar

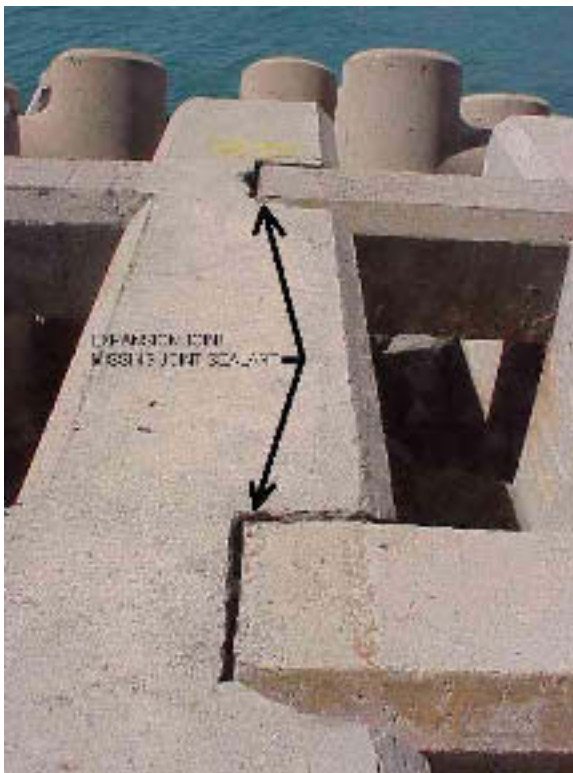
uu. Dan's Sta. 29+24 = East B/W Sta. 24+24, OS, filler in expansion joint missing on concrete ribcap (see similar picture "ddd").

vv. Dan's Sta. 29+77 = East B/W Sta. 24+72, OS, filler in expansion joint missing on concrete ribcap (see similar picture "ddd").

ww. Dan's Sta. 30+25 = East B/W Sta. 25+20, OS, filler in expansion joint missing on concrete ribcap (see similar picture "ddd").

aaa. Dan's Sta. 30+73 = East B/W Sta. 25+68, OS, filler in expansion joint missing on concrete ribcap (see similar picture "ddd").

ddd. Dan's Sta. 31+15 = Misc. Part I Sta. 26+10, filler in expansion joint missing on concrete ribcap.

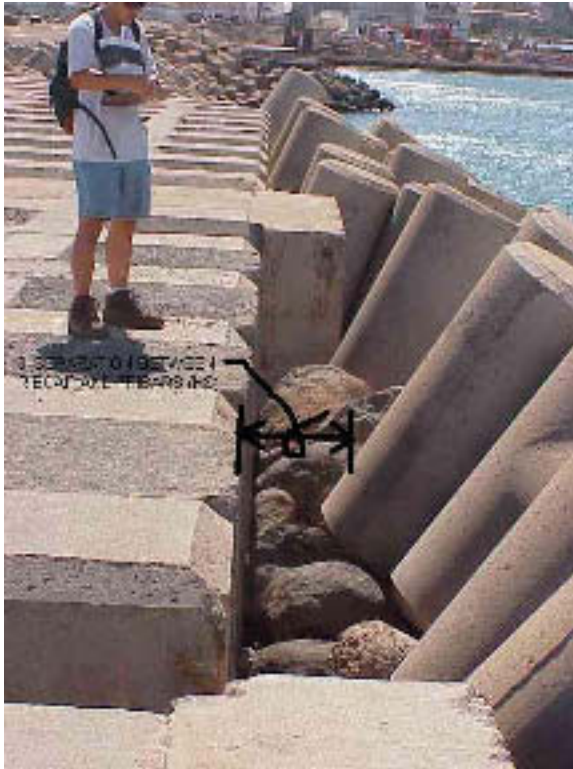
fff. Dan's Sta. 31+51 to 31+93 = East B/W Sta. 26+46 to 26+88, 3' separation from ribcap to tribars; side slope could be settling. Monitor.

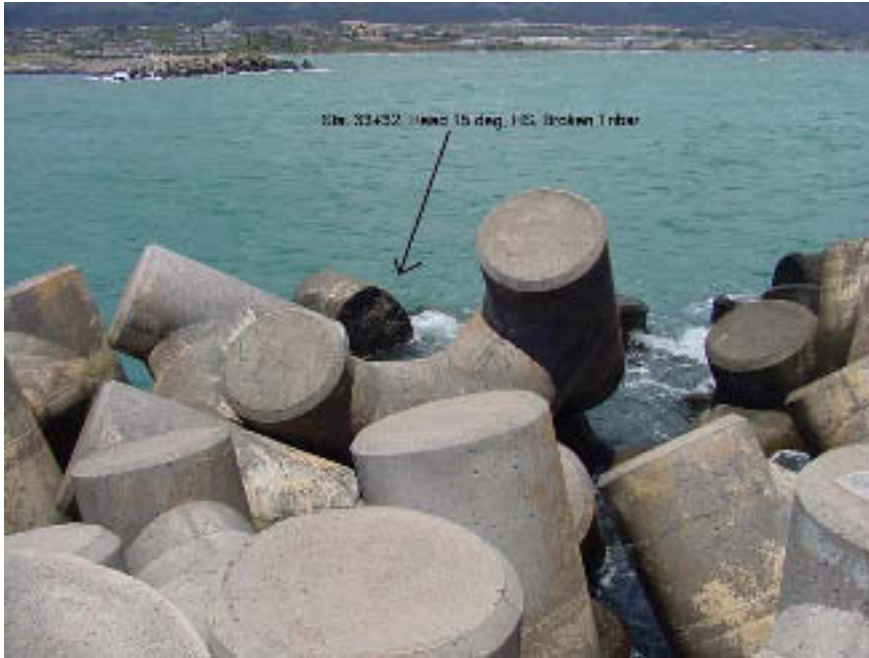
iii. *Dan's Sta. 33+32, 15 deg HS, broken tribar.

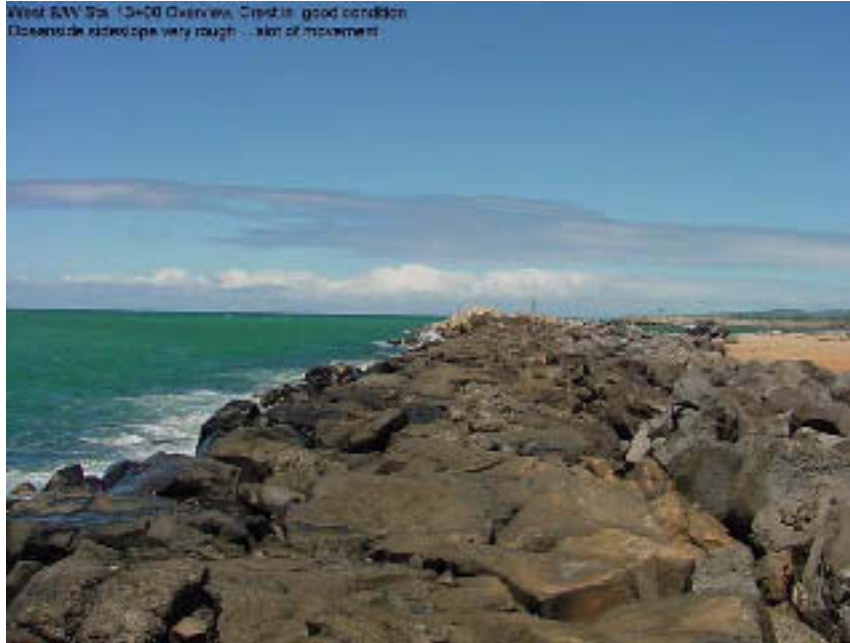
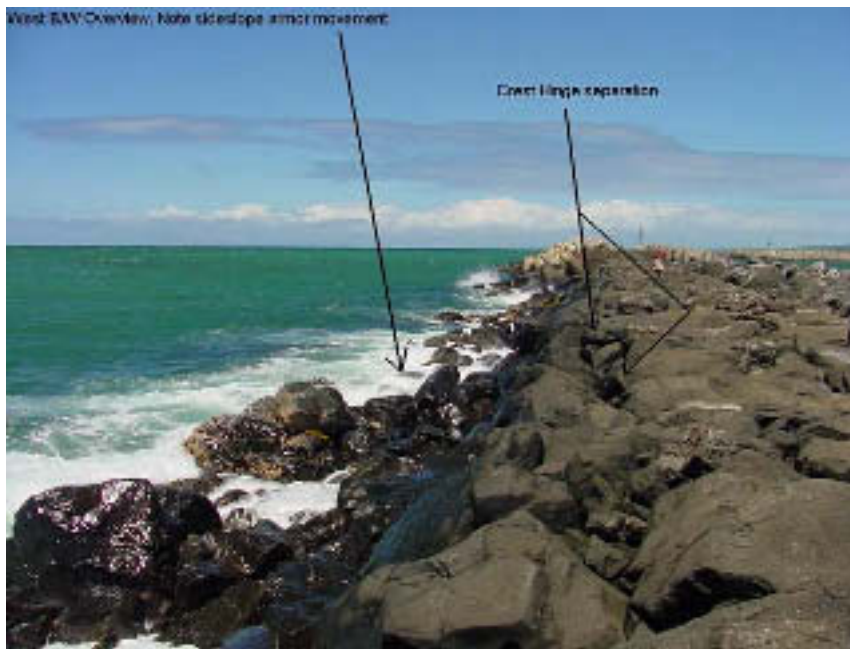
a. *Sta. 13+01 thru 17+41, OS, monitor sideslope for settling and steepening, continue to monitor 4 ea outcropping (rocks/old armor stone) adjacent to toe.

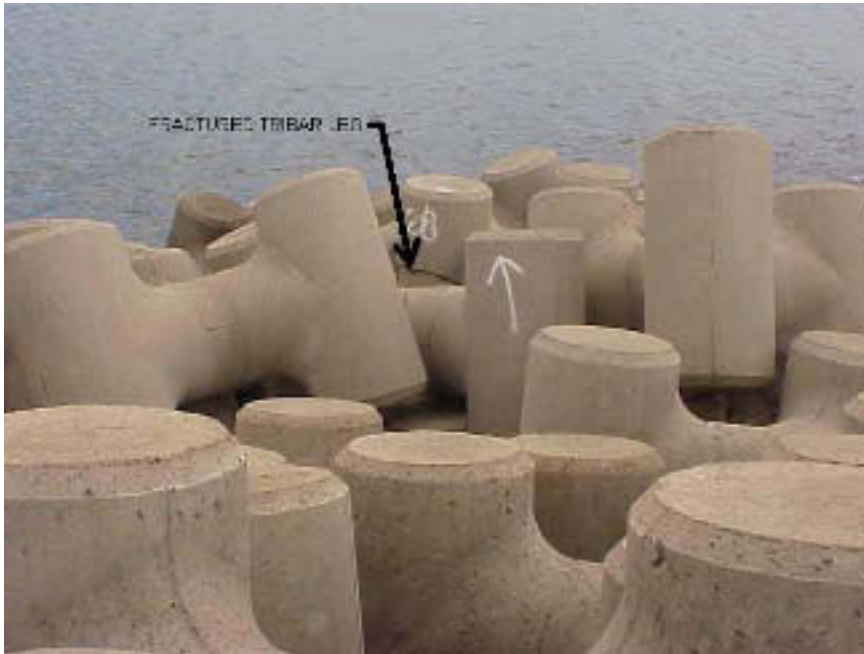
b. Sta. 17+95, HS, 1ea fractured tribar leg on slope.

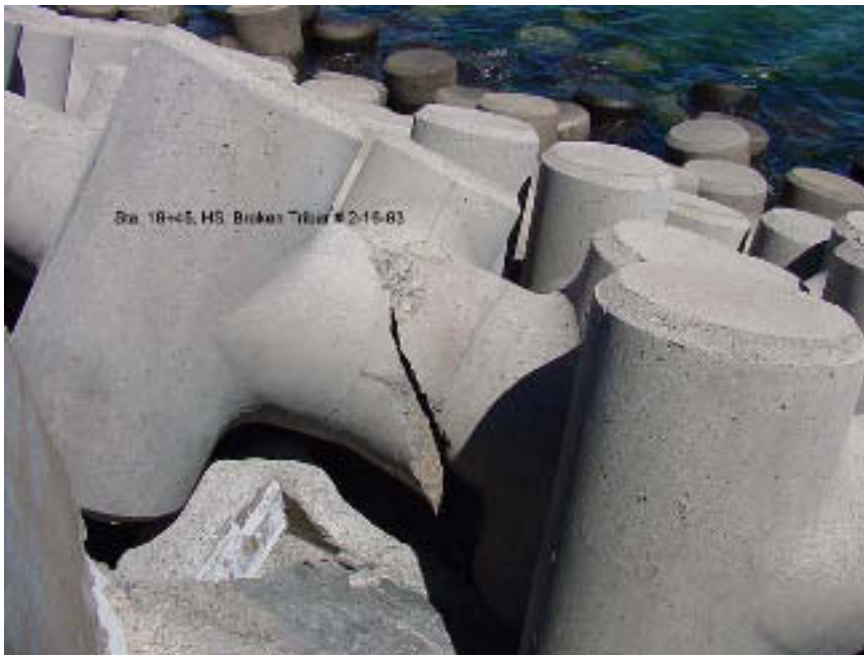
c. *Sta. 18+45, HS, 1ea broken tribar, # 2/16/83 at mid-section.

d. *Sta. 18+50, HS, 1ea broken tribar, at mid-section $\frac{1}{2}$ down the sideslope # 1/5/83.

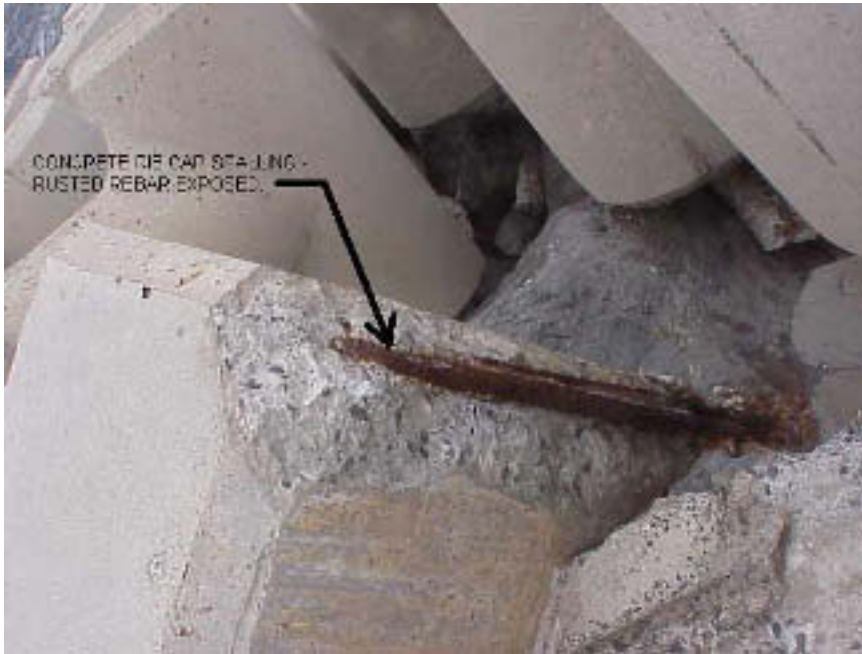
g. Sta. 19+60, HS, Ribcap corner spalling. Rusted rebar exposed.

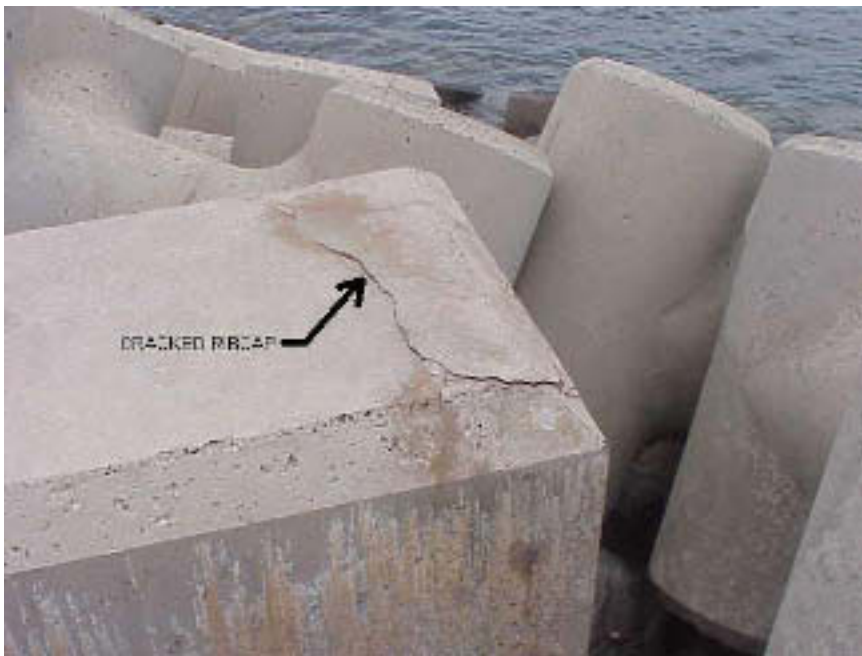
h. Sta. 19+84, HS, Ribcap cracked.

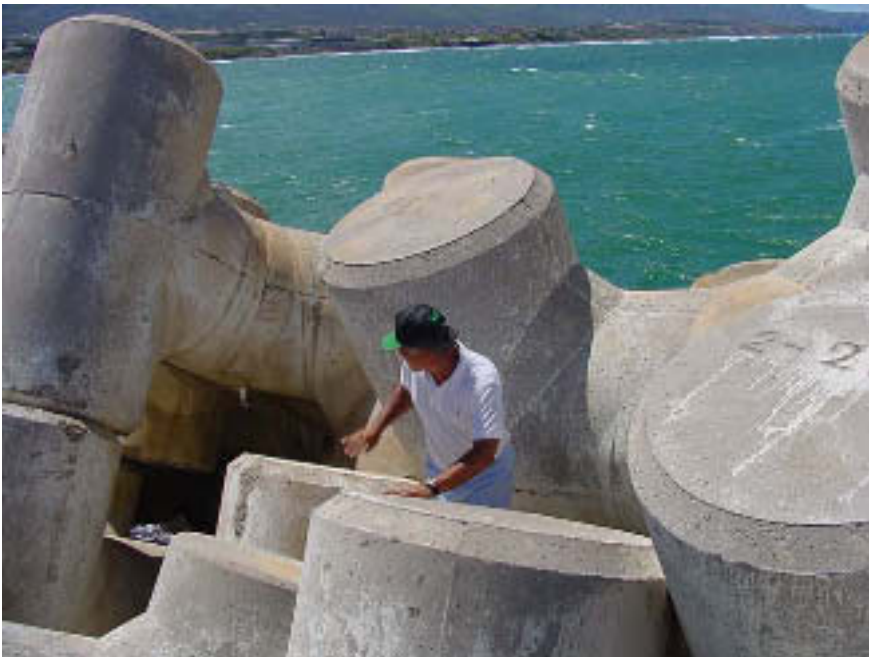
j. *Sta. 20+90, OS, 1 broken tribar at mid-section.

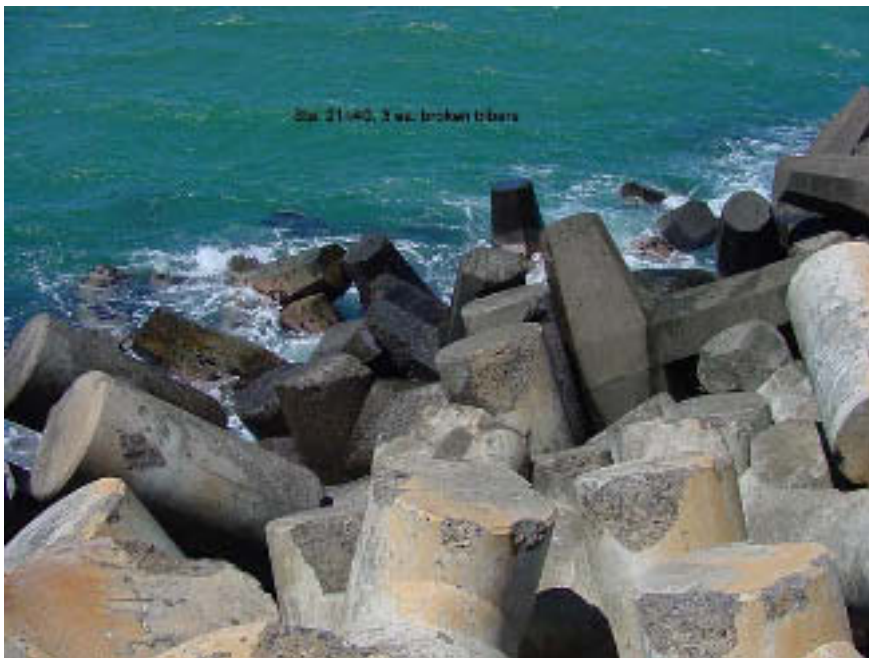
- n. *Sta. 21+40, OS, 3ea broken tribars at mid-section; 1ea broken dolos (shank/fluke).

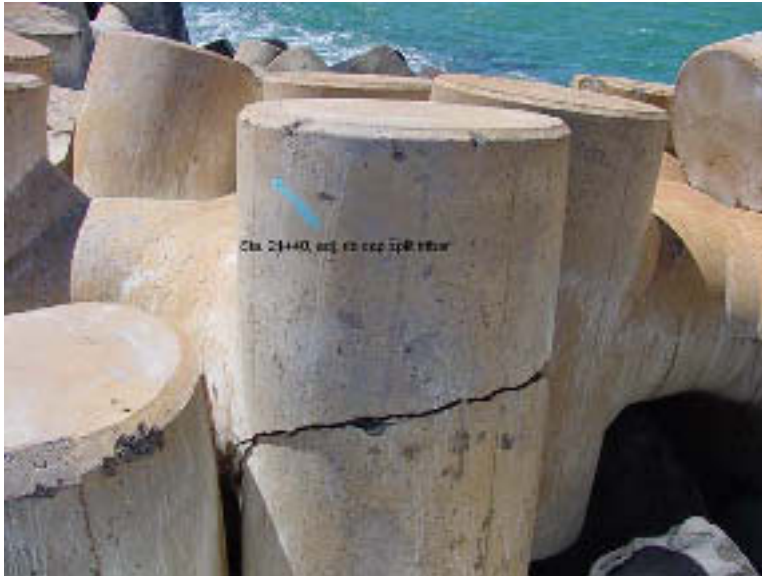
- o. *Sta. 21+40, OS, Broken tribar # 3/5/69 @ rib cap.

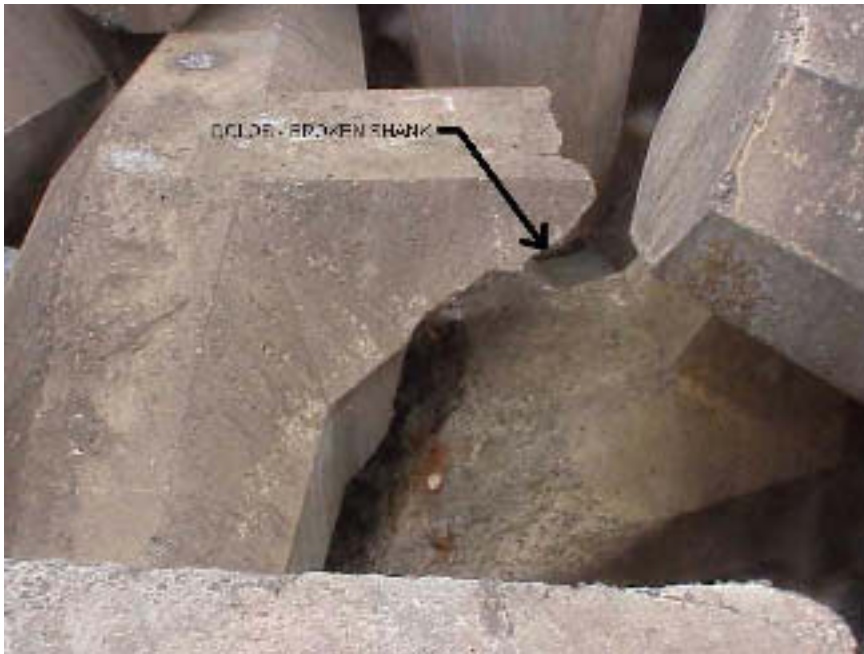
r. Sta. 23+00, OS at Head, 1 broken shank dolo at hinge (pictured above) and 1 broken shank dolo at toe (not pictured).

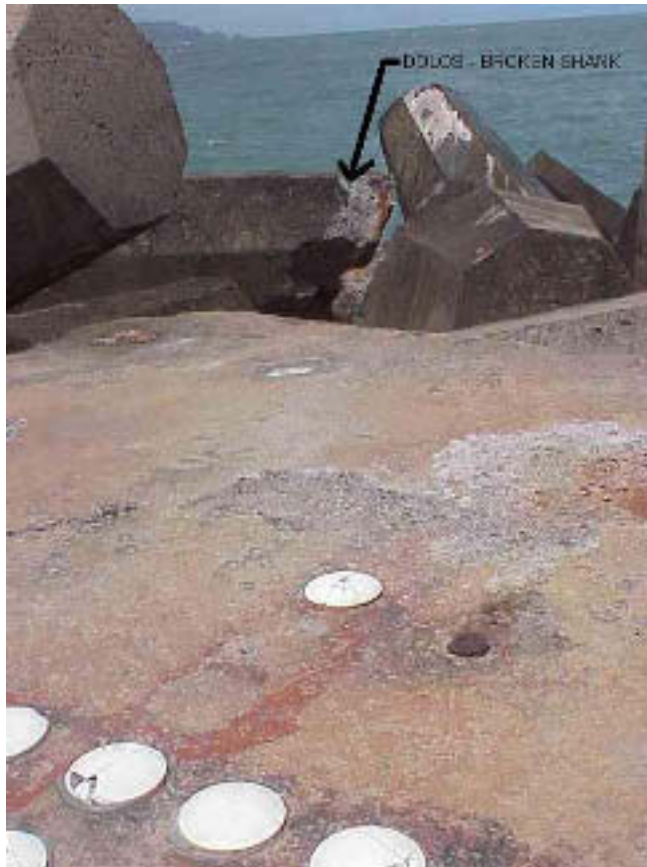
bb. Sta. 23+25, OS at Head, 1 broken shank dolo (pictured above), and 1 broken fluke shank on near toe (not pictured).
